## DAMAGE IN HISTORIC RAMMED EARTH STRUCTURES: A CASE STUDY AT AMBEL, ZARAGOZA, SPAIN

### ABSTRACT

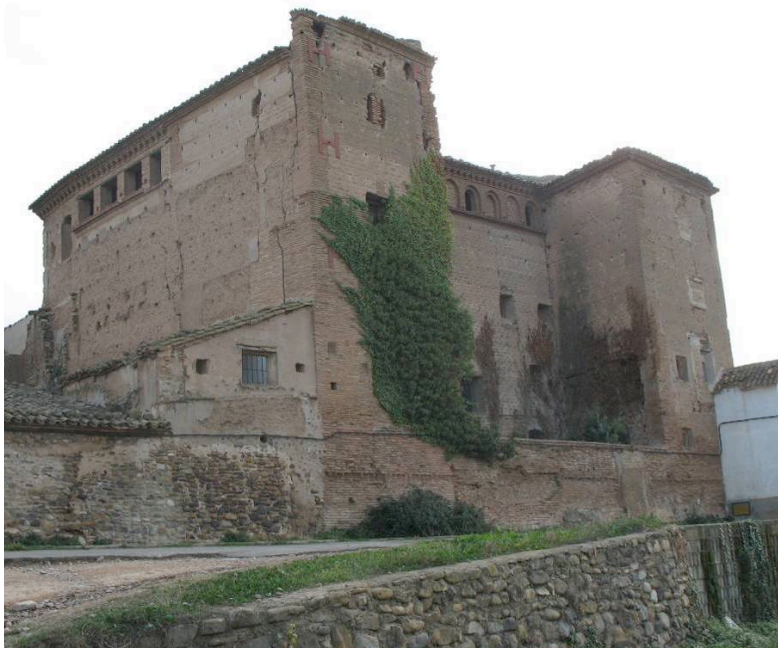
Today there are two independent sets of cracks in the east elevation (Fig. 1) – two slightly inclined cracks in the centre of the building; and two vertical cracks at the north end of the east elevation, which are related to the lean of the north gable end wall. This wall leans outwards from ground level to mid-height of the second storey, with the section above this being built vertically on top of a leaning wall. The current owners of the building installed crack monitoring points in the early 1990s and this monitoring shows the continued opening of the cracks at the northern end of the tower. As a result,

Fig. 1. The preceptory at Ambel, north-east elevation. The gallery of arches between the towers is typical of 16th century architecture in this region. The first phase precinct wall reaches the base of ivy and stands 3m high.

shows that there is no structural tie between the between the two. Any structural movement therefore results in an opening of the joint. This is particularly a problem in later medieval architecture, where brick quoins are used, and structural movement (for example of the gable end of a structure) is unrestrained and leads to an opening of the joint. An example of this can be seen on Fig. 1 immediately below the eaves at the northern end of the tower.

Where water has been allowed to gather and run down the face of a wall, cast structures, such as described in Section 4.1, are observed on the face of the wall (Fig. 5). However, these have served as a forewarning of further damage and caused the building owners to undertake repairs. As a result, there are no deep incisions into the rammed earth as shown in Fig. 4, and as observed at other historic rammed earth sites (Jaquin, 2008b). However, the eaves do not protrude on any of the faces, and this may have allowed a water flow down the face of the wall. If water is allowed to gather behind the render, then the rammed earth may become locally saturated, meaning the liquid bridges providing a bond between the render coat and the rammed earth may become saturated, causing the render to spall away from the wall (Fig. 1).

tie bars were placed at ceiling level at the ground, first and second storeys in 2000. These are fixed internally by bolting onto the ceiling beams and protrude externally to link to H-shaped bars on the facade which were positioned so as to overlap the brick quoins (Fig. 1).
