Tilemachos Andrianopoulos

The Athens Conservatory Concert Hall by Jan Despo: Restoration, Reuse, Research.

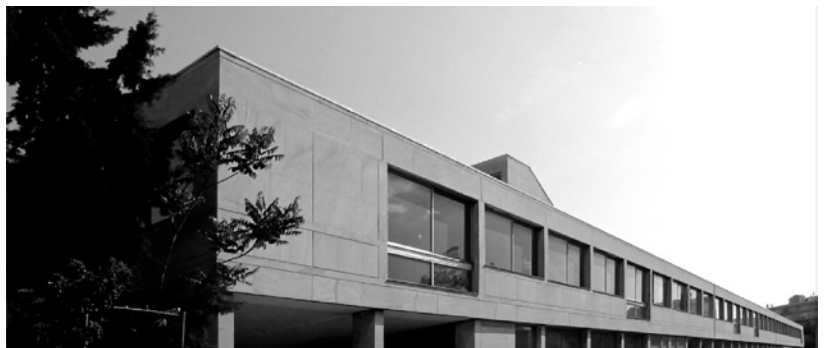
Fig. 5 The Athens Conservatory, Northern Elevation, 2009. Source: T.Andrianopoulos

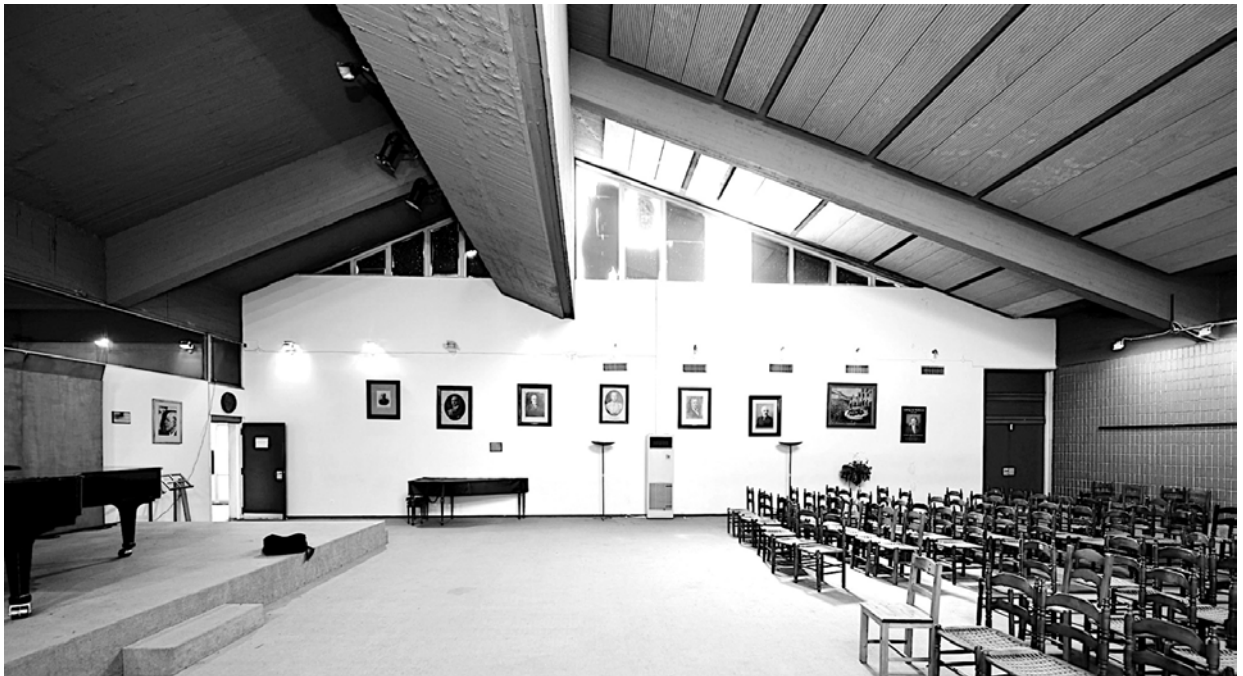
Fig. 6 The Athens Conservatory, Upper Concert Hall before restoration, 2017. Source: T.Andrianopoulos.

The latter served as the Conservatory's space for the teaching of lyric art as well as its main music venue for 40 years, though it also remained in an incomplete, decadent state due to lack of funding. The Concert Hall forms a whole with a more closed, quadrate space for theater performances – separated by common supporting facilities. A grid of concrete beams runs through both roofs, though the one of the music hall is dramatically different: an almost 4 meters-high twin beam of a length of 15 meters divides the space in two areas, forming an impressive non symmetric skylight. The roof is constructed by exposed reinforced concrete while one of the white-plastered lateral walls conceals another unique 5 meters pre-tensed beam that spans a length of 35 meters and permits the circular-like set up of the subjacent amphitheater. The gradual wear of time, the additive arbitrary interventions in terms of furnishing and decoration, and the unfinished state of the mechanical equipment urged for a restoration which was furthermore demanded, according to the School's decision to present a more extrovert public activity. The restoration was commissioned to tense architecture network, led by the writer, and atelier66, led by Dimitris and Suzanna Antonakakis. The restoration's main aim was to retrieve the splendor of the Hall's structure while removing the dull interventions of almost half a century.

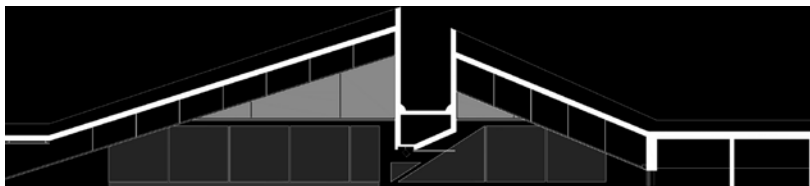
Fig. 10 The Athens Conservatory, Upper Concert Hall section (detail), 2018. Source: atelier66 and tense architecture network.
