**POST-EARTHQUAKE CONSTRUCTION AND DEMOLITION WASTE MANAGEMENT:  
THE CASE OF THE 2023 TURKEY EARTHQUAKE\***

Burhan Kubilay Kaptan

\* O texto desta nota corresponde a uma comunicação apresentada no VI Congresso Internacional de Riscos, tendo sido submetido em 15-09-2023, sujeito a revisão por pares a 17-11-2023 e aceite para publicação em 31-01-2024. Esta nota é parte integrante da Revista *Territorium*, n.º 32 (N.º Especial), 2025, © Riscos, ISSN: 0872-8941.

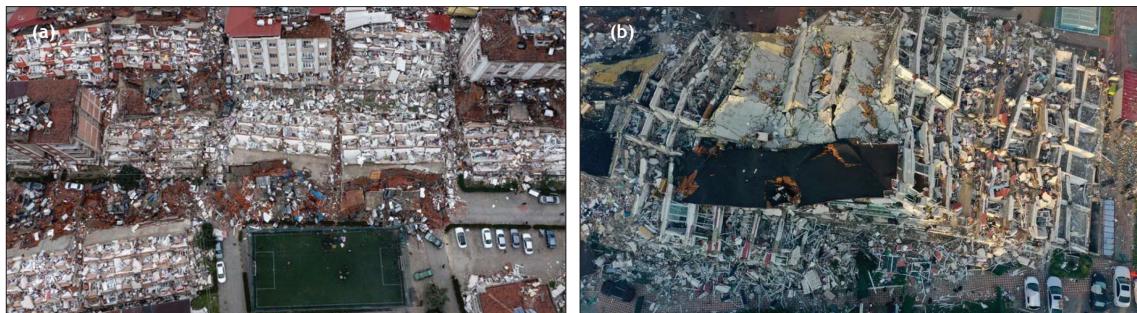
In the provinces of Kahramanmaraş and Adiyaman, it has been seen many cases of "soft storey". In places like Hatay-Antakya and Adiyaman-Gölbaşı, it has also been seen that buildings collapsed in an angled position by sinking into the ground, or the whole building leans to one side or sinks into the partially liquefied ground (fig. 2) (ITU, 2023; TMMOB, 2023; Reliefweb, 2023).

Fig. 2 - Examples of damaged buildings: (a) Hatay, (b) Kahramanmaraş (Source: TMMOB, 2023).

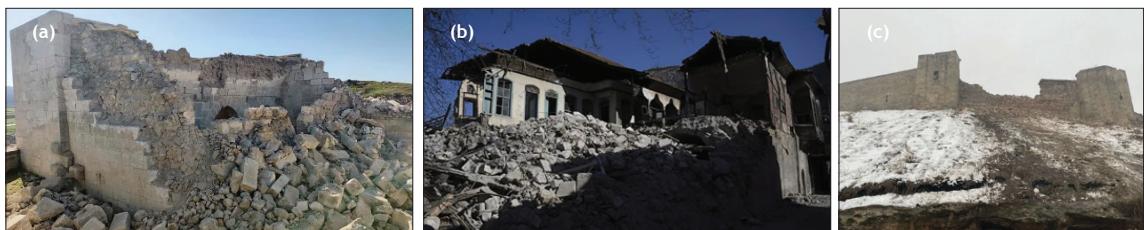
**Photo 1** - Examples of damaged historical buildings: (a) Gaziantep İçkale Mosque, (b) Historical Antakya Houses, (c) Gaziantep Castle (Source: TMMOB, 2023).

Historical artifacts destroyed or damaged by the earthquakes are Habib-i Neccar Mosque, Antakya Ulu Mosque, Church of Saints Peter and Paul, Malatya Yeni Mosque, Gaziantep Castle, Karakuş Tumulus Pylon, Diyarbakır Walls, Diyarbakır St. George Church, Historical Antakya Houses, Darb-i Sak Castle, Hazrat Ukkâşé Tomb and Gaziantep İçkale Mosque (photo 1 and photo 2). There is no evidence or record that damaged or undamaged particles of these historical artefacts are kept in accordance with the regulations.

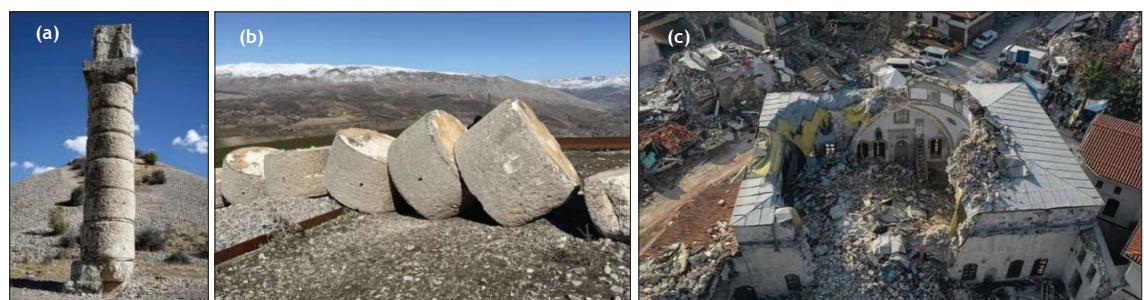
**Photo 2** - Examples of damaged historical buildings: (a) Karakuş Tumulus Pylon, (b) Church of Saints Peter and Paul (c) (Source: TMMOB, 2023).
