Man's action and slope erosion. A case study in Tâmega Basin (1981) *

António de Sousa Pedrosa**
Bernardo de Serpa Marques ***

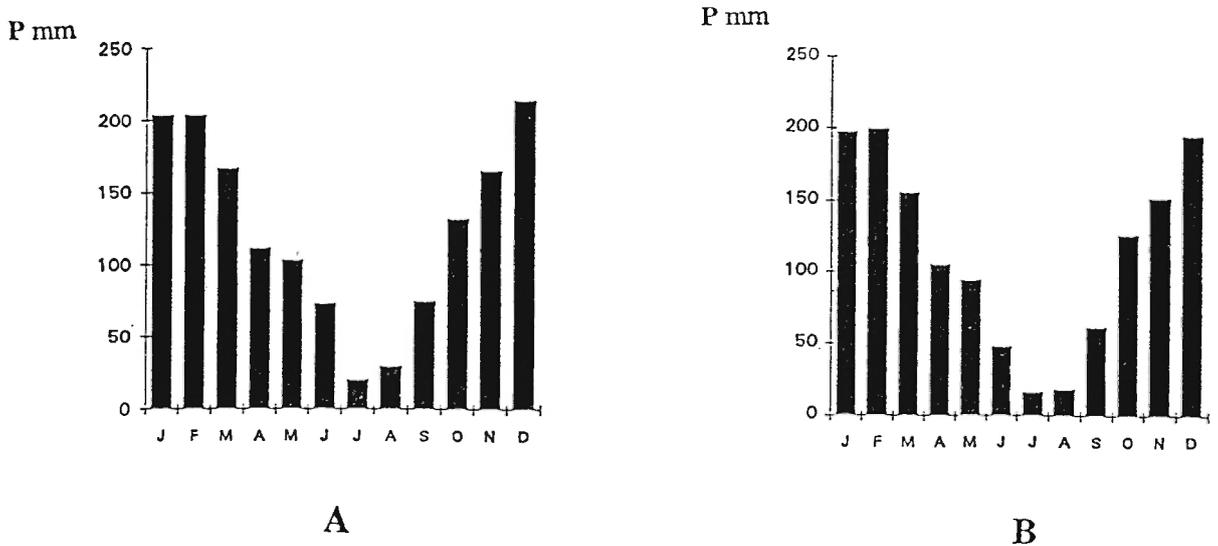
Fig. 1- Rainfall graphs (A-Cavez; B - Ribeira de Pena). Source: INMG (National Institute of Meteorology and Geophysics).

Though situated in quite different exposure conditions, the two meteorological stations located nearest to the Arosa basin - Cavez and Ribeira de Pena - register yearly values as high as 1400 mm

(Fig. 1) while the number of days of rainfall is more than 100. The numbers show clearly that this is an area of heavy rainfall. Nevertheless, the distribution of the rainfall along the year is not regular; the wet months are followed by a hot dry summer with mediterranean characteristics.

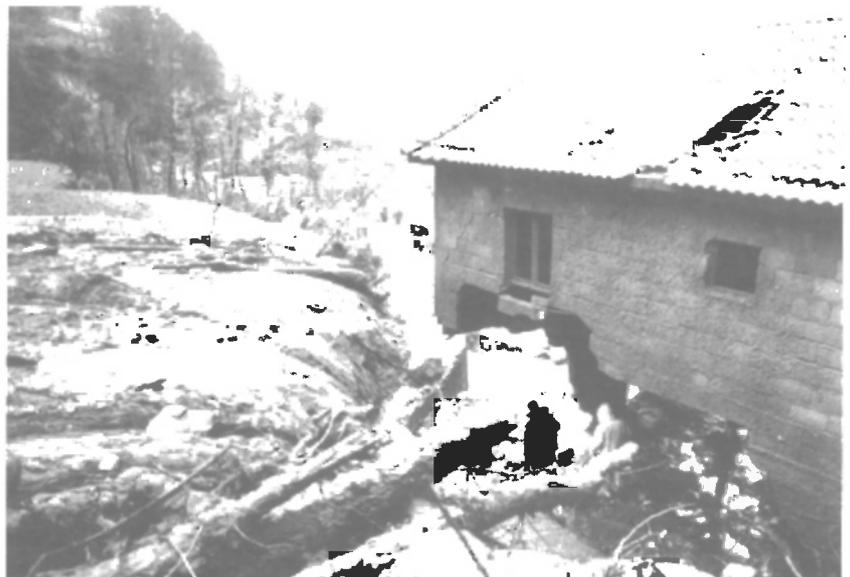
Fot. 1 - The building damaged by the landslide.

There was no way this enormous mass of mud and rocks could pass through the narrow channel that was the normal course the brook water took to flow under the 211 Road. When it overflowed, it found in its way a building made of stone and brick which had very unwisely been built directly on the talweg. It simply broke down the walls, left part of the upper floor without support and added to the moving mass, not only the building materials it had snatched away but also all the furniture and the people inside the building. It only stopped, as said before, when it reached the foot of the slope, i.e., in the bed of the river Tâmega.

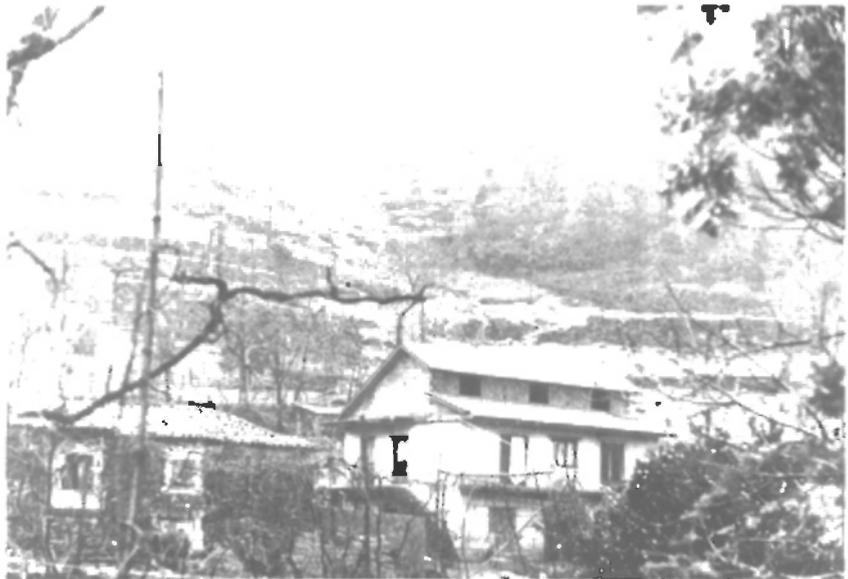
Fot. 2 - The small valley of the Arosa brook and the scar caused by the landslide.

and a maximum width of 17 meters. In all, the landslide affected an area of 828 square meters (Fot. 2). The scarp had a median height of 1.5 meters which allows us to estimate the total volume of the materials removed at about 1,240 cubic meters.

On the slope it left a longish scar in the direction of the maximum slope, with a length of 69 meters

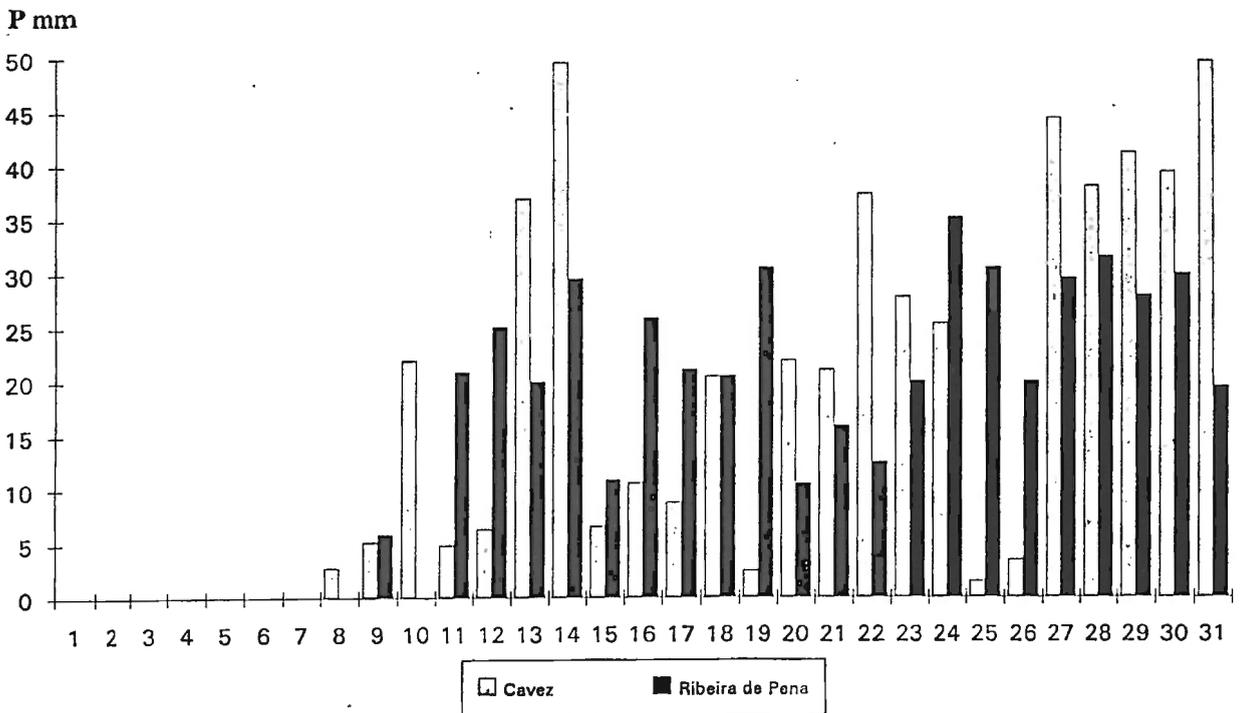
Fig. 2 - Daily rainfall records (mm)(December 1981). Source: INMG (National Institute of Meteorology and Geophysics).

The observation of the records of the daily rainfall registered in the nearest meteorological station (Fig. 2) show that in the days before the event it had rained very heavily for 20 days in Cavez and 18 in Ribeira de Pena. While in Cavez there had been nine days with rainfall less than 10 mm, in Ribeira de Pena it rained more than 10 mm every day. The mentioned records show that the total amount of rainfall in the twenty days preceding the disaster reached 397.6 mm in Cavez and 415.8 in Ribeira de Pena. Such values are uncommon for this area; the average rainfall for the month of December in both villages is less than 200 mm (Fig 3).

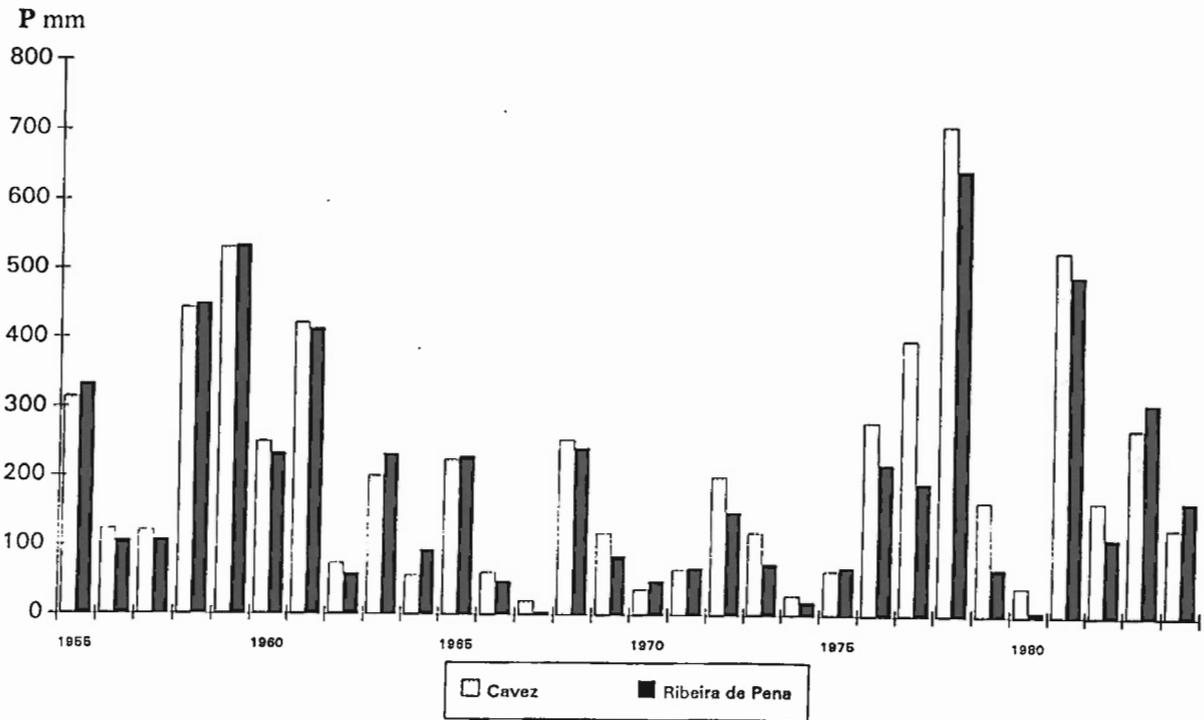
Fig. 3 - Amount of rainfall in the month of December in the area around the Arosa brook. Source: INMG (National Institute of Meteorology and Geophysics).

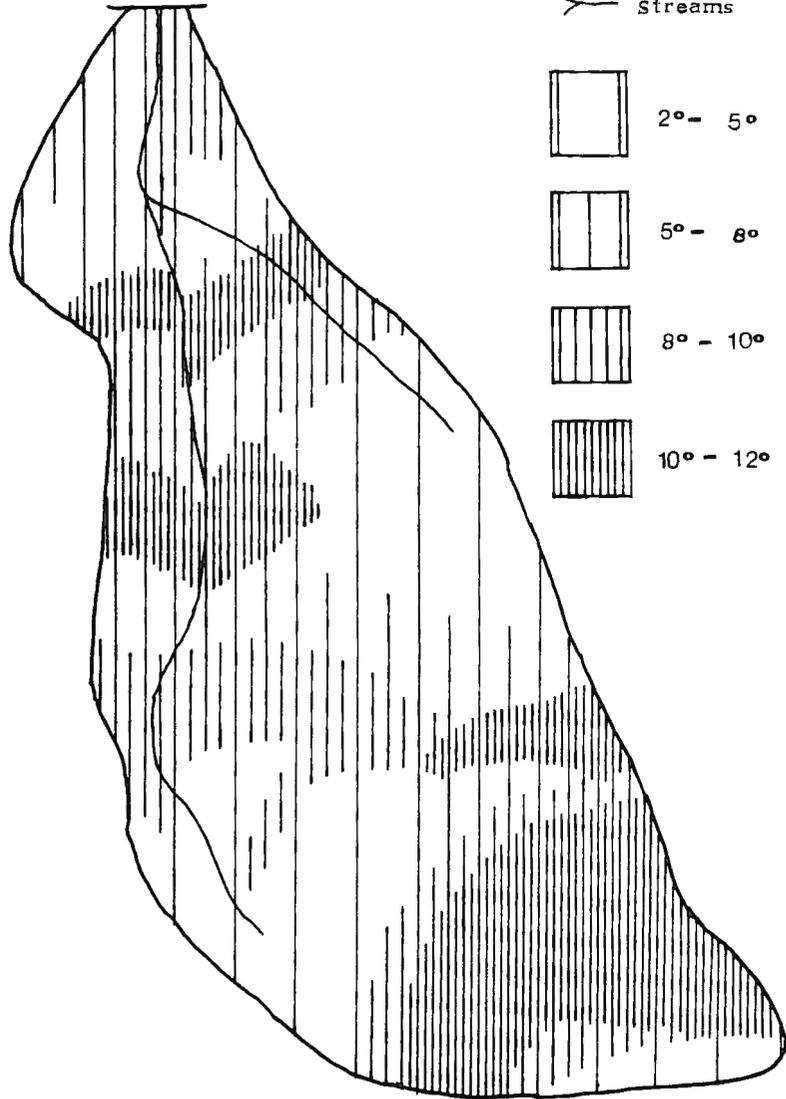
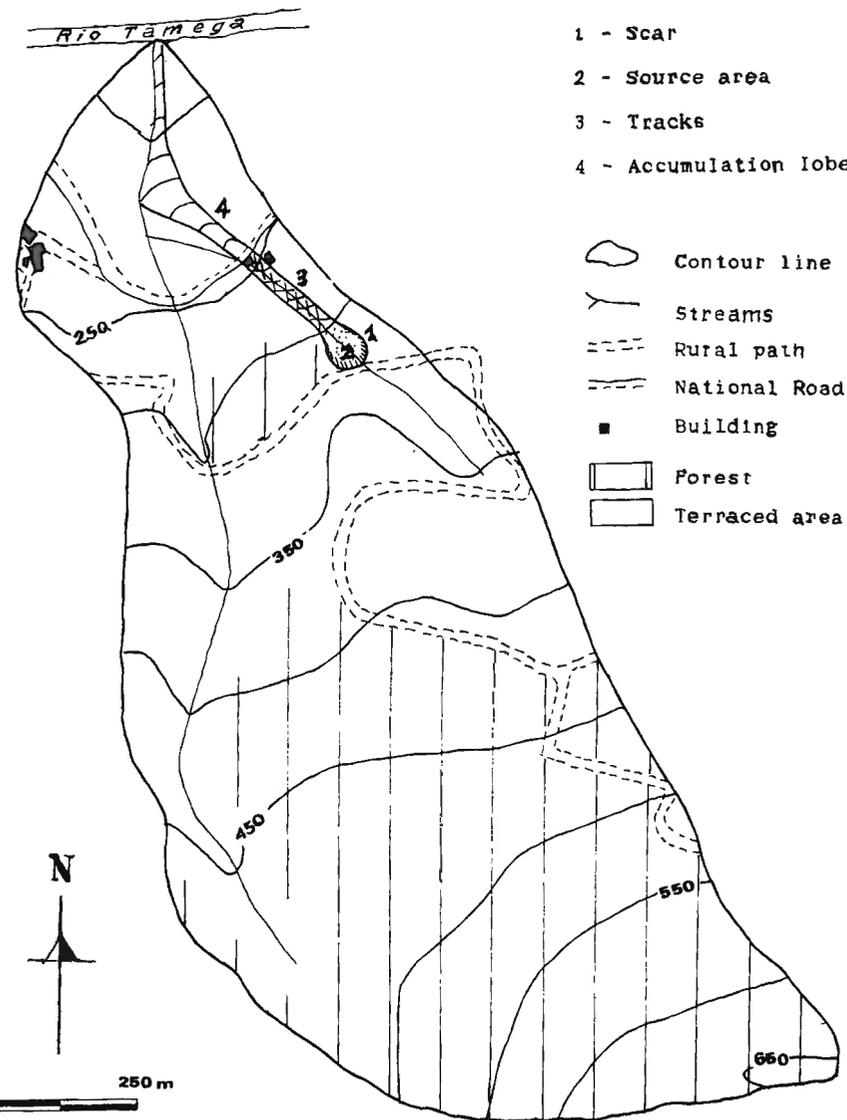
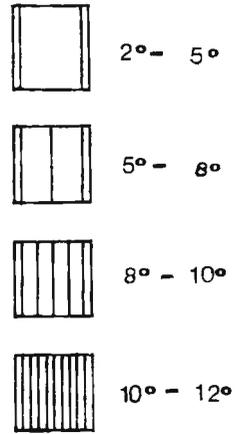
SLOPE ANGLES

LANDSLIDES

- 1 - Scar
- 2 - Source area
- 3 - Tracks
- 4 - Accumulation lobes

Fig. 4 - Slope angles and site of the landslides in the Arosa brook basin.

Another determining factor concerns the steepness of the slopes which characterize the whole basin (Fig. 4). The map shows that inclines between 8½ and 18½ are predominant in the basin but they alternate with areas where the slopes are gentler (YOUNG, 1972). The landslide began in one of the places with the steeper incline.

In our opinion the element that most contributed to increasing the intensity of this natural phenomenon has something to do with the alteration of the natural conditions of the runoff caused by a rural path (Fig. 4). It was built to enable the farmers to get to their fields and to the forest. It winds up the slope, disregarding the small streams it crosses and goes even into the next basin. Thus, besides concentrating all the runoff, the path itself has become an element of the drainage system, as if it were a river bed. A large part of the runoff, together with the water it collected on its way through the neighbouring river basin, was consequently channelled to a place
