THE ASSESSMENT OF EROSION IN AOULAI WATERSHED (CENTRAL RIF MOUNTAINS, MOROCCO) BASED ON THE  
PAP-RAC GUIDELINES APPLICATION\*

Mostafa Hmamouchi

**Keywords:** Erosion, assessment, Aoulai watershed, Rif mountains, PAP-RAC.

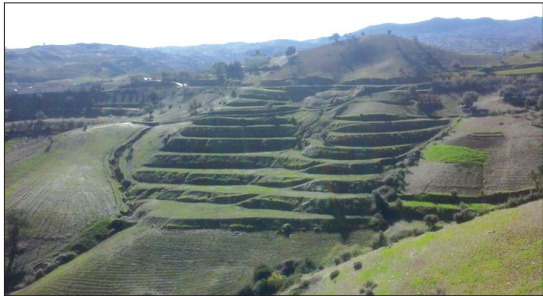
The maps of the susceptibility to the erosion, and the forms of the erosion derived from frequent field visits and using satellite images, demonstrated that the Aoulai watershed is known by a strong morphodynamical action, through the associated forms, from sheet erosion, rill erosion, gully erosion till bad lands (photo 1).

Photo 1 - Different forms of water erosion in Aoulai watershed area, situation in December 2016.

The forms and the highly eroded slopes show the combination between environmental factors; fragile lithology, concentrated runoff in time and space and steep slopes, and the exploitation of slopes by human activities unsuited to the nature of the surface. The repercussions of this strong erosion, the loss and destruction of the soil and the threat of infrastructure and environmental problems reflected in the socio-economic skills of the settlers, due to the decline of land use, soil fertility and sustainability of the agricultural system for future generations, and the threat to human facilities and equipment (such as roads and irrigation channels).

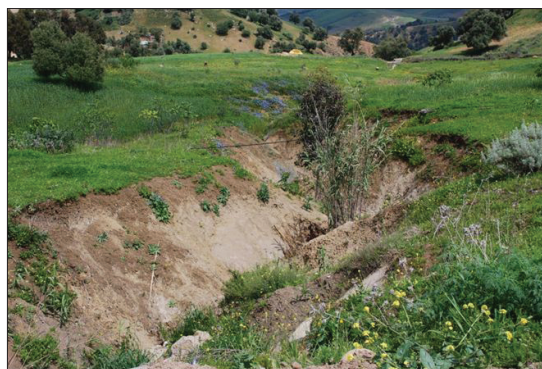
- Strong and very strong erosion zones: this covers the bare and semi bare areas, and the annual cultivation of the shale and clay slopes that belong to the Jurassic era and are marked with steep slopes as well as weak resistance. These areas cover about 588 km<sup>2</sup> of the watershed area (72%) which are clearly located along the watershed and are particularly in upstream on the slopes look over in the Aoulai Wadi, where the ravines and meanders are clearly expanded (photo 2);

**Photo 2** - Active erosion and deposition in upstream sector of Aoulai watershed in Bab berd and Tamroute areas, situation in December 2016.
